Barrel Repair: When Does It Make Sense?

By Randy Elliott

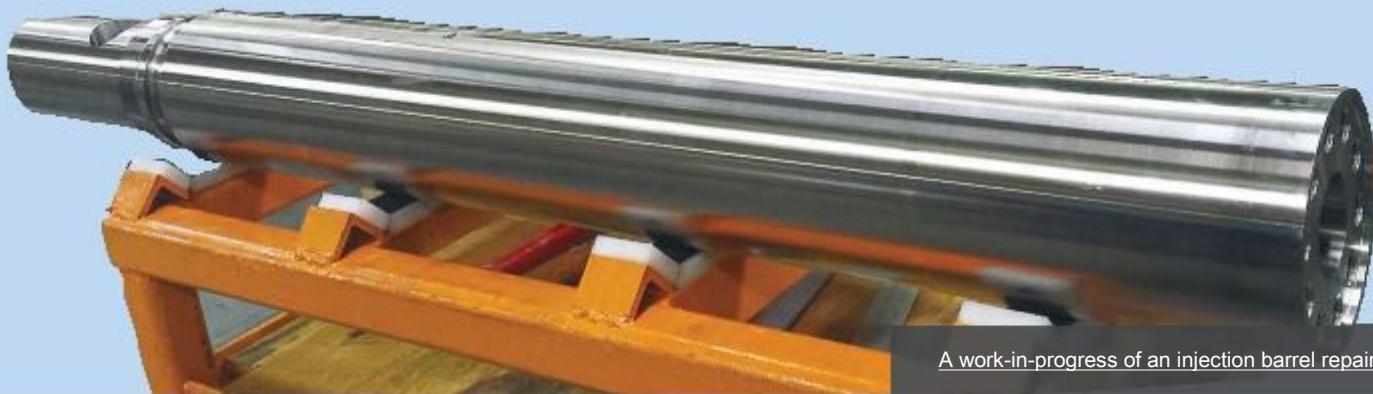
A work-in-progress of an injection barrel repair.

- The barrel is placed in a boring machine specially built for rigidity to prevent vibration while a long boring bar and special boring head are used.
- The inner wall of the barrel is bored out so that the resulting bore is approximately 1.0 in. larger than the original bore. This step is particularly difficult, since it involves boring through the extremely hard bimetallic inlay, along with a portion of the backing steel that makes up most of the thickness of the barrel. Boring has to be accomplished while maintaining

- A new bimetallic liner is machined to approximately 0.5 in. wall thickness, maintaining an OD tolerance of 0.001 in. The liner, which consists of a hard bimetallic inlay material plus backing steel, has an OD that is actually slightly larger than the ID of the bored-out barrel.

- Through a special heat-shrinking process, the liner is secured with an interference fit inside the barrel.
- Final machining and polishing takes place. Ask your supplier to take the extra step of re-machining the installed barrel liner to ensure concentricity. Even when produced under the most exacting conditions, a repaired barrel never quite achieves the degree of straightness, concentricity, strength, or heat transfer available with a new one. When straightness is greatly compromised as a result of a poorly done repair job, it can lead to accelerated wear. Another risk involved when a repair is not carried out properly is that an air pocket is left between the liner and the
